**ELLIS ISLAND
STATUE OF LIBERTY NATIONAL MONUMENT**

**HISTORIC STRUCTURES REPORT
UNITS 2, 3 AND 4**

**Volume 4
Part Two**

**Beyer Blinder Belle/
Anderson Notter Finegold**

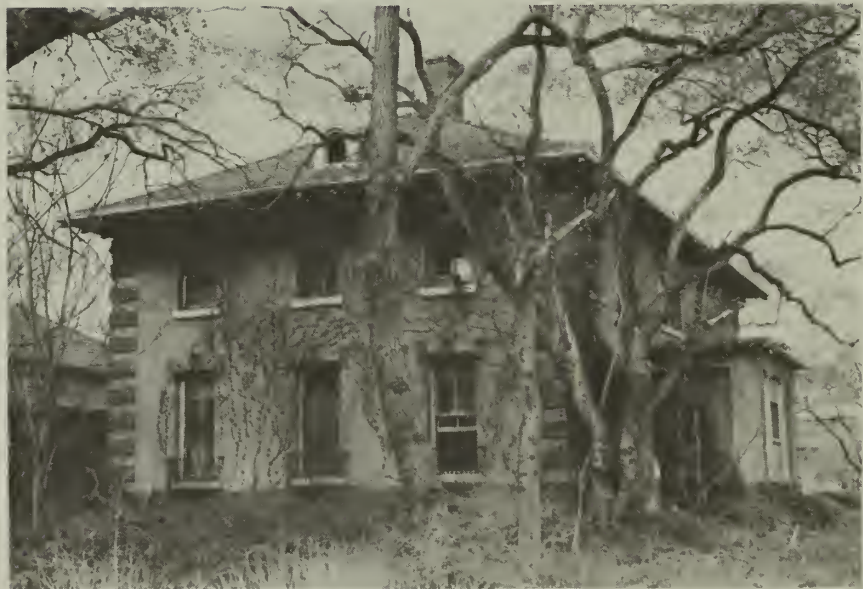
4. South elevation, view northwest.

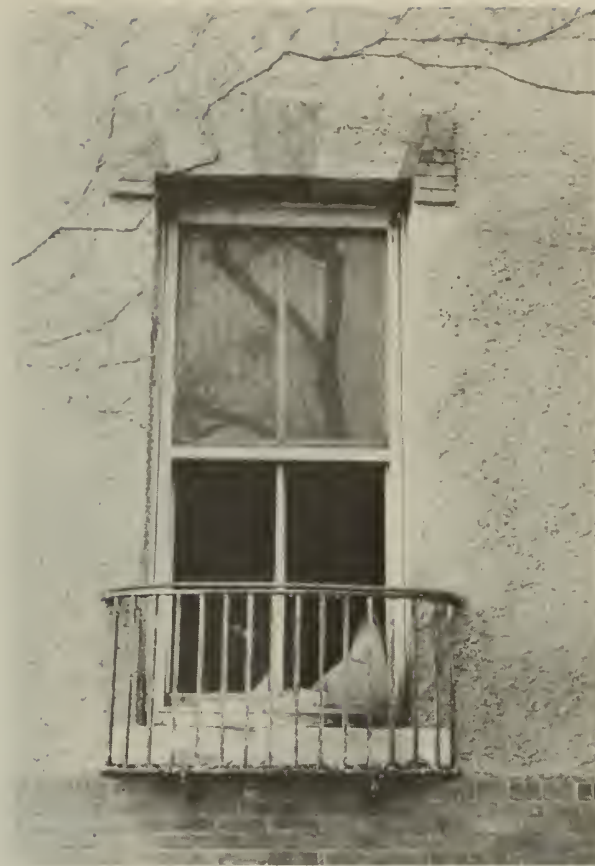
5. Typical first story window,  
west elevation.

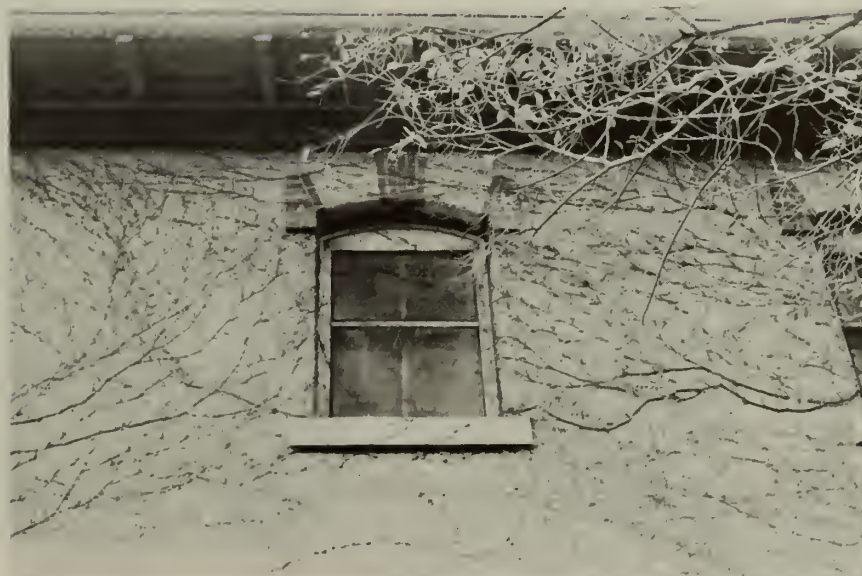
6. Typical second story window,  
west elevation,

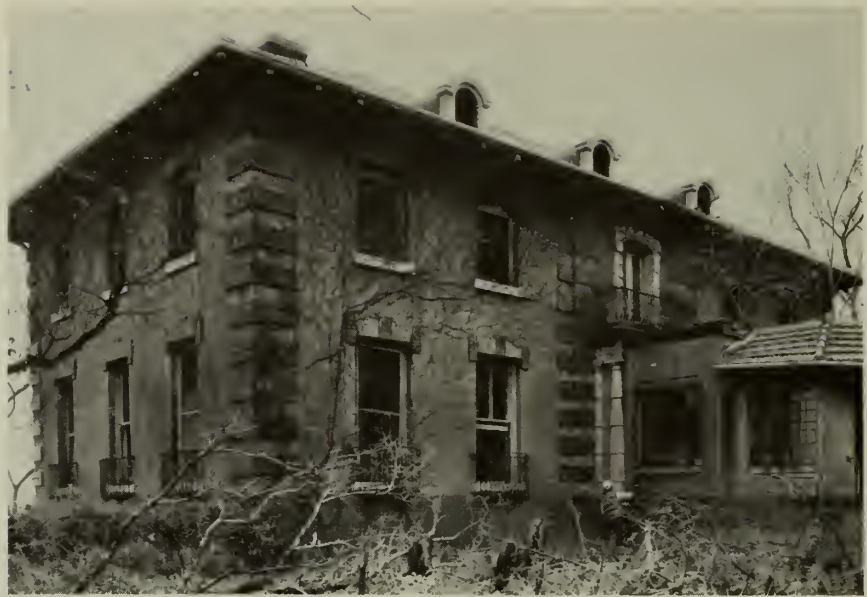
7. West elevation, view southeast.

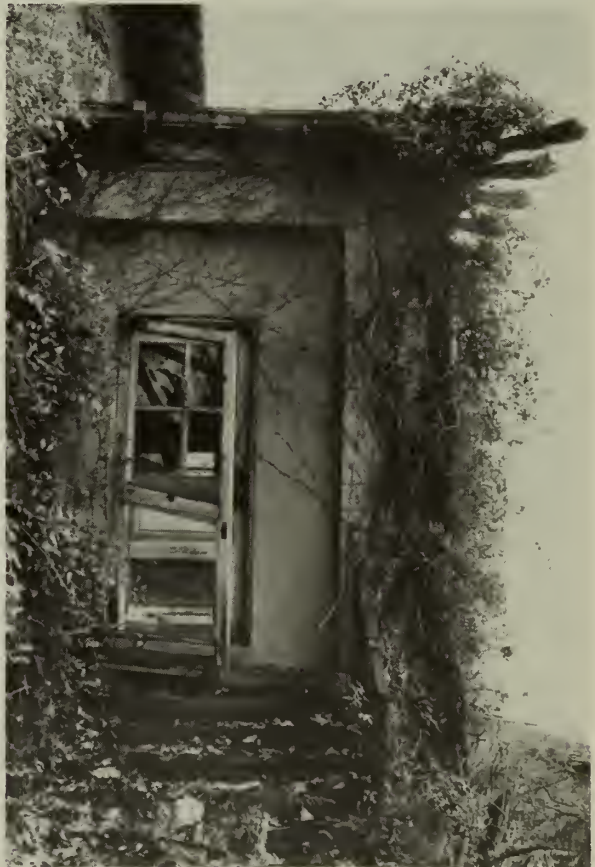
8. Door, south side of porch.

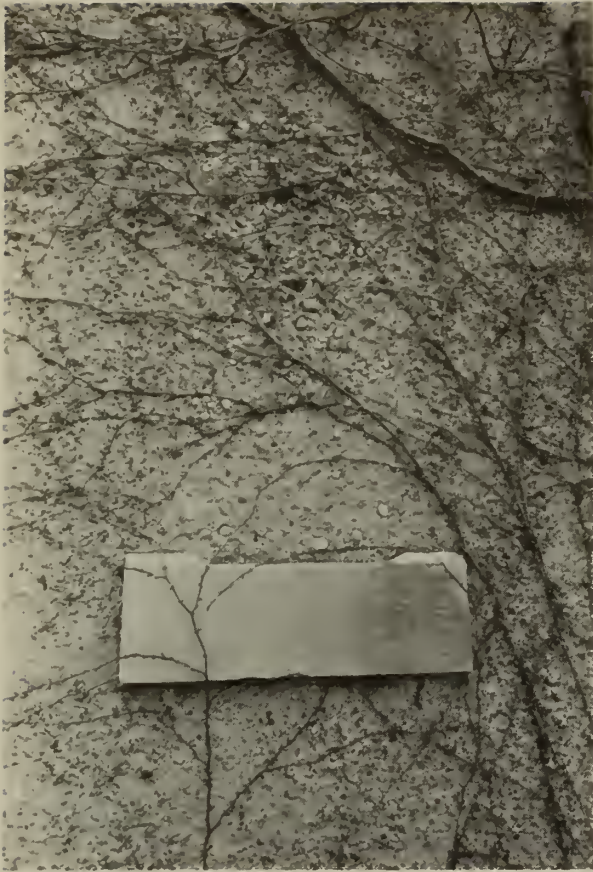
9. Exposed sill and stucco infill, east elevation.

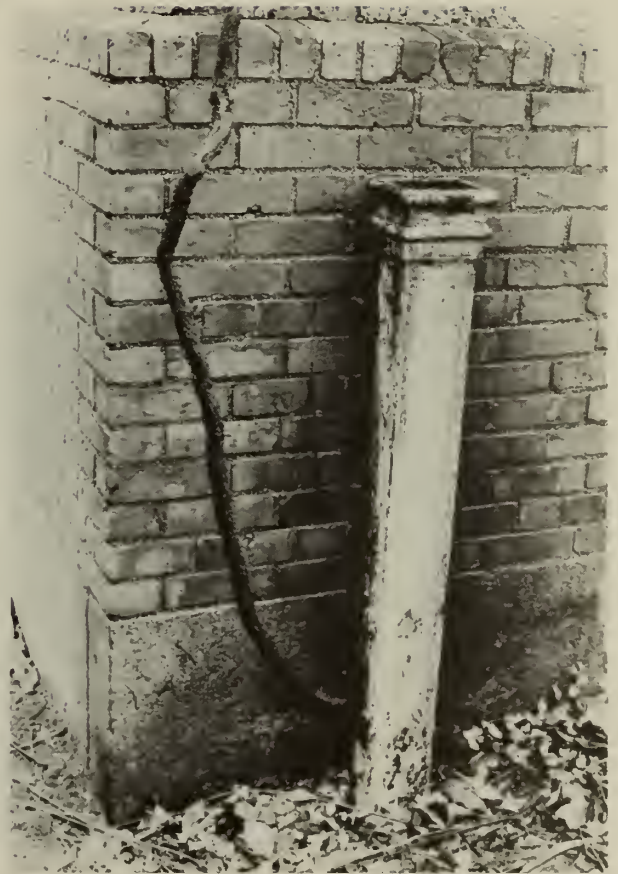
10. Downspout receiver, south-west corner.

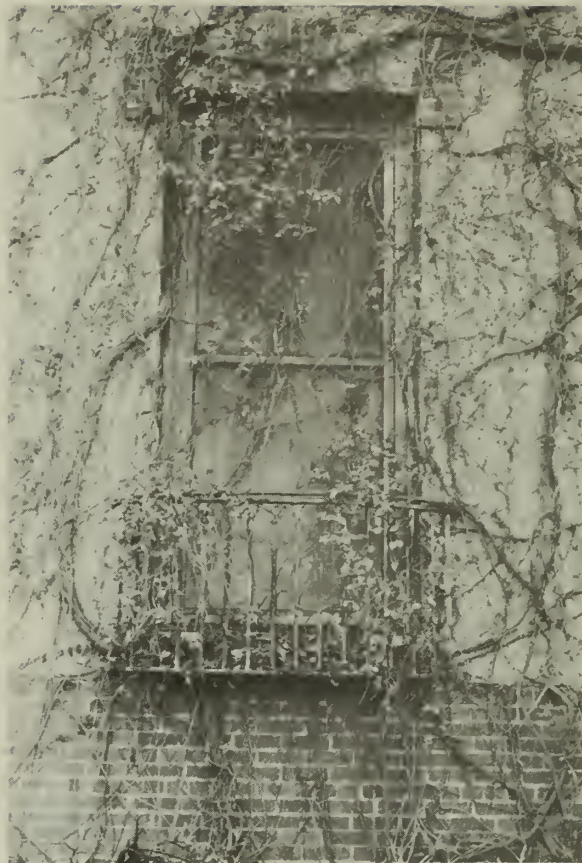
11. Vine-growth, east elevation.

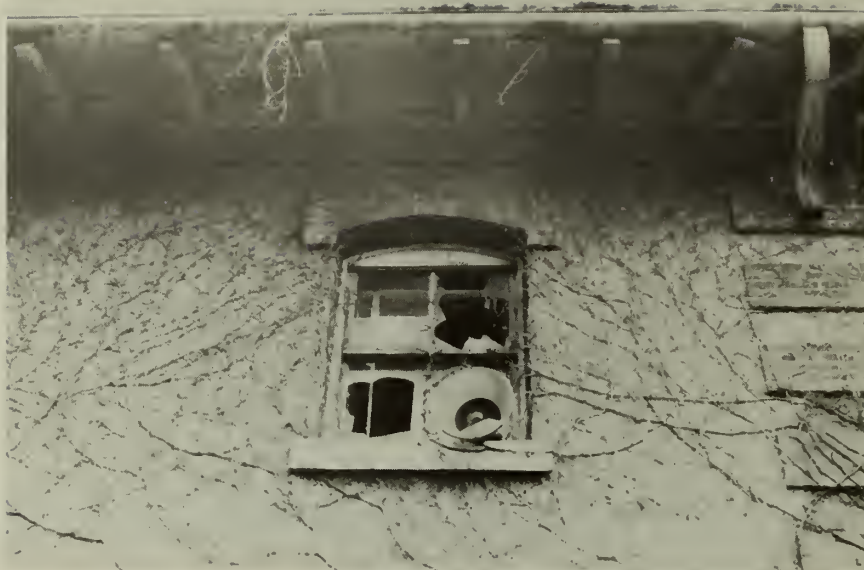
15. Spotlight in window, south elevation.

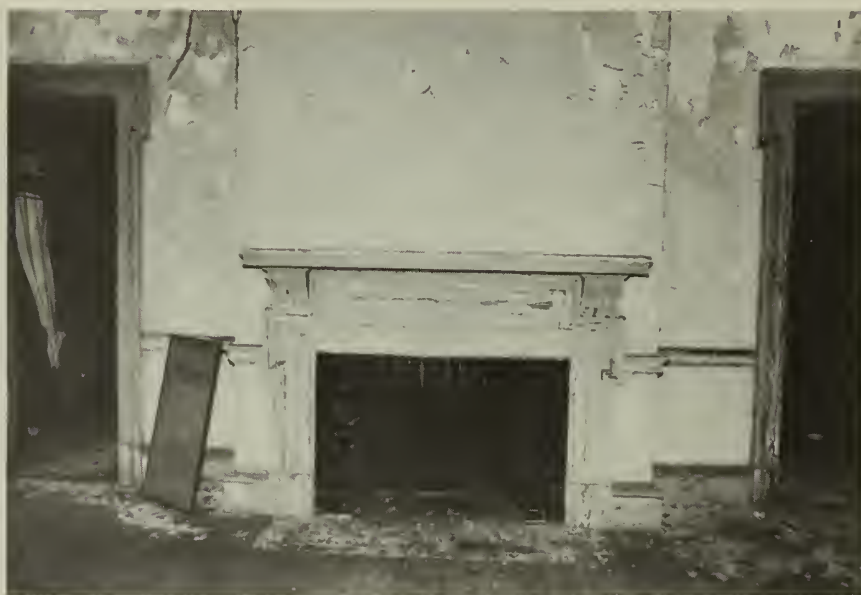
16. Fireplace, library, room 103.

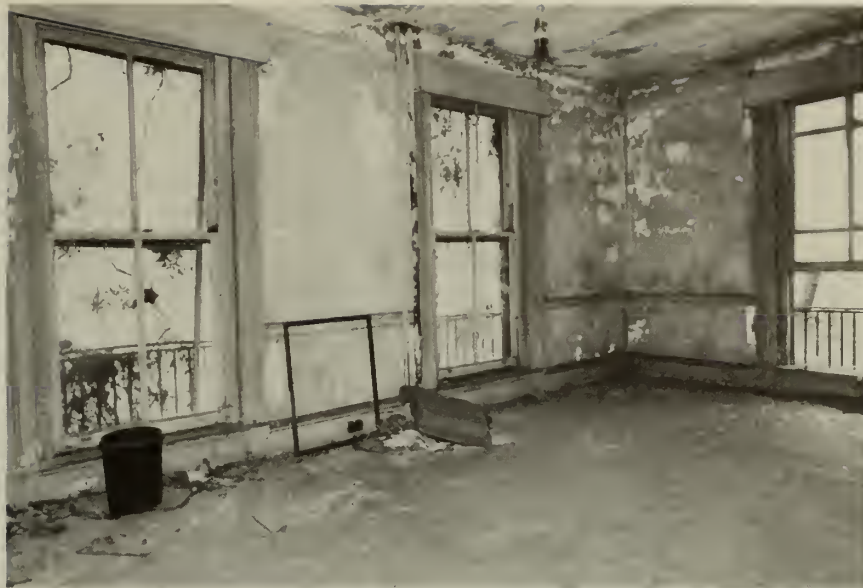
17. Windows with wood valances, room 103.

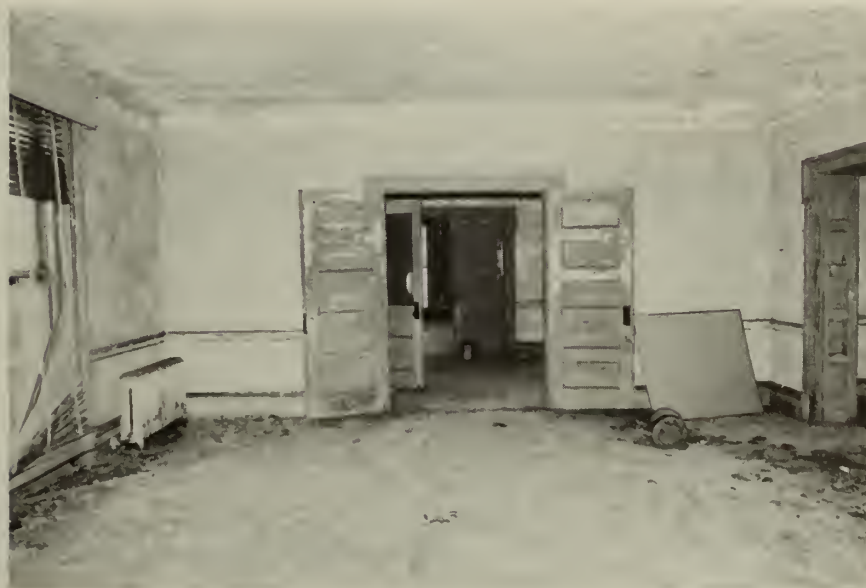
18. Double doors, living room, room 104.

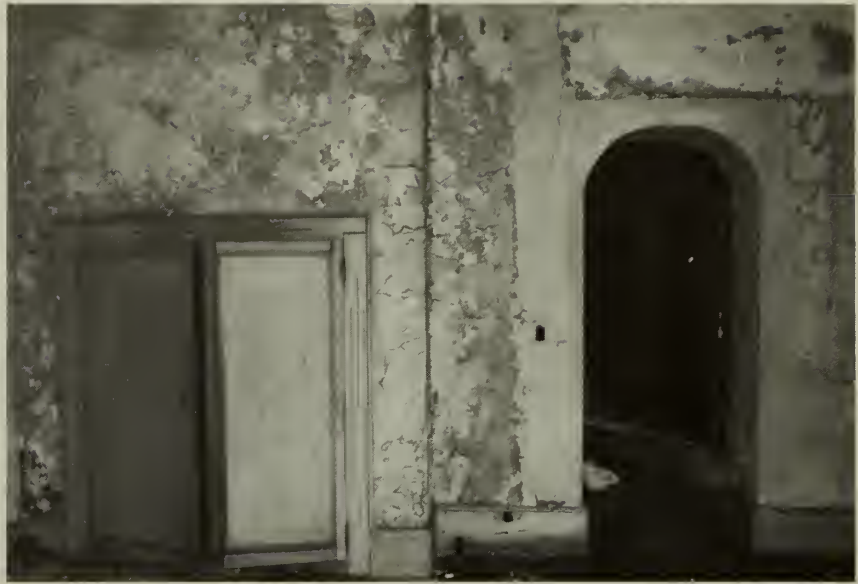
19. Arched doorway and cupboard, room 102.

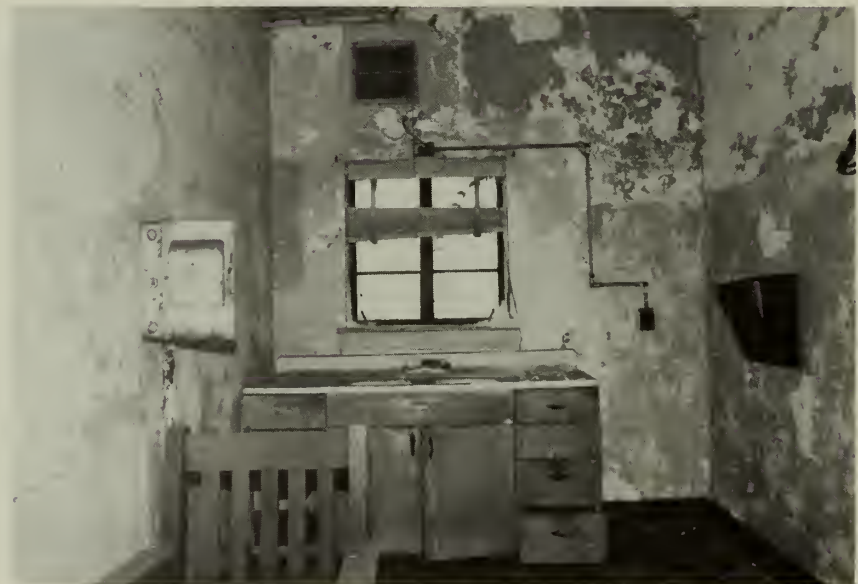
20. Sink, room 102.

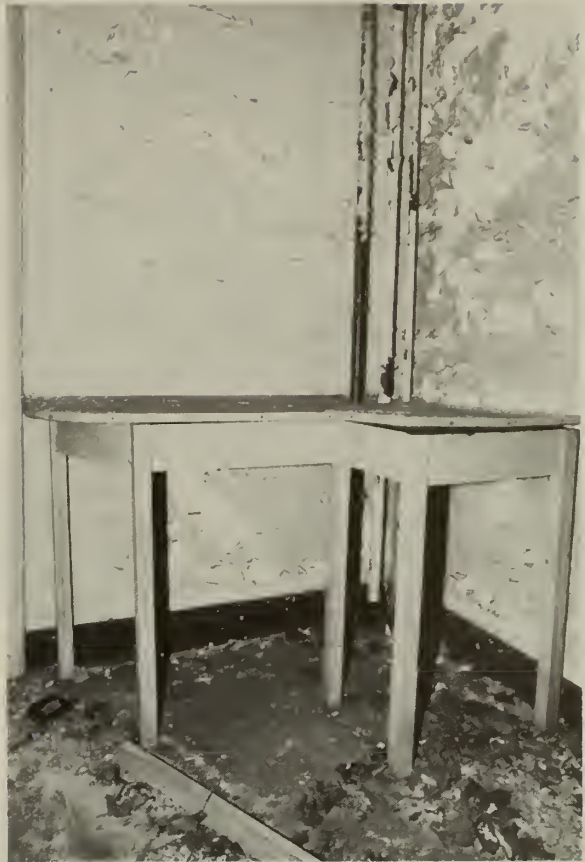
21. Counter, room 102.

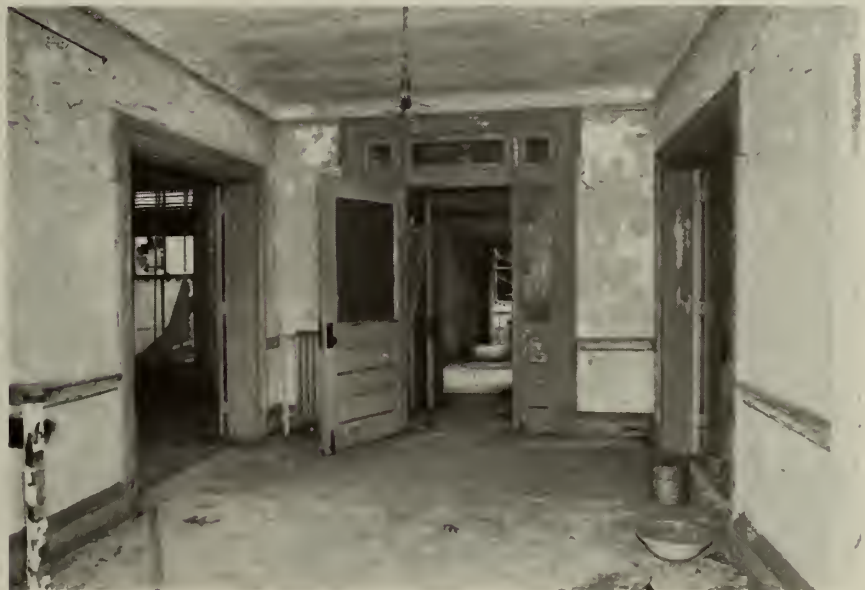
22. Door to H102.

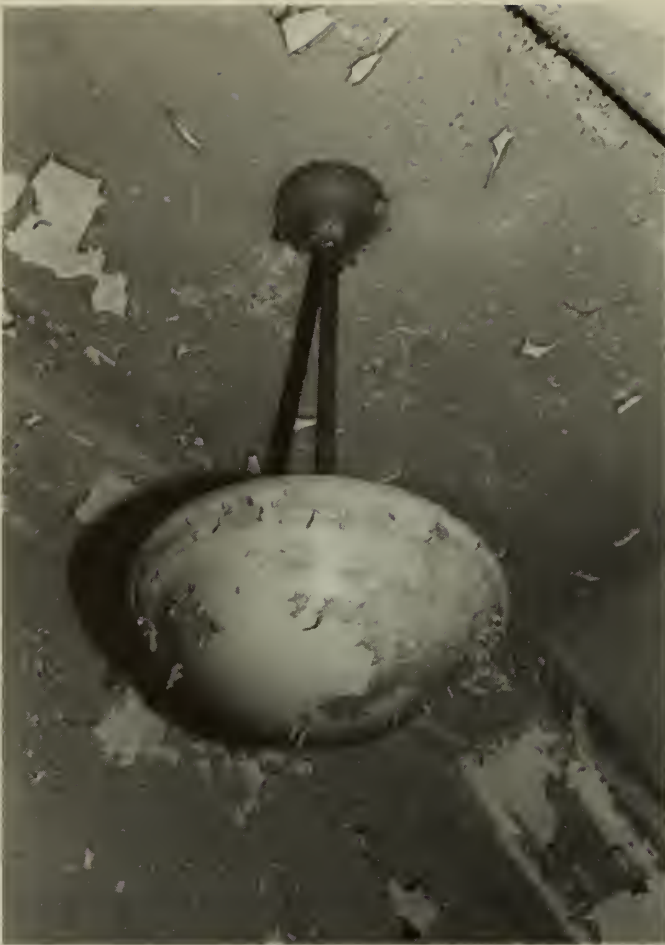
23. Typical light fixture, H102.

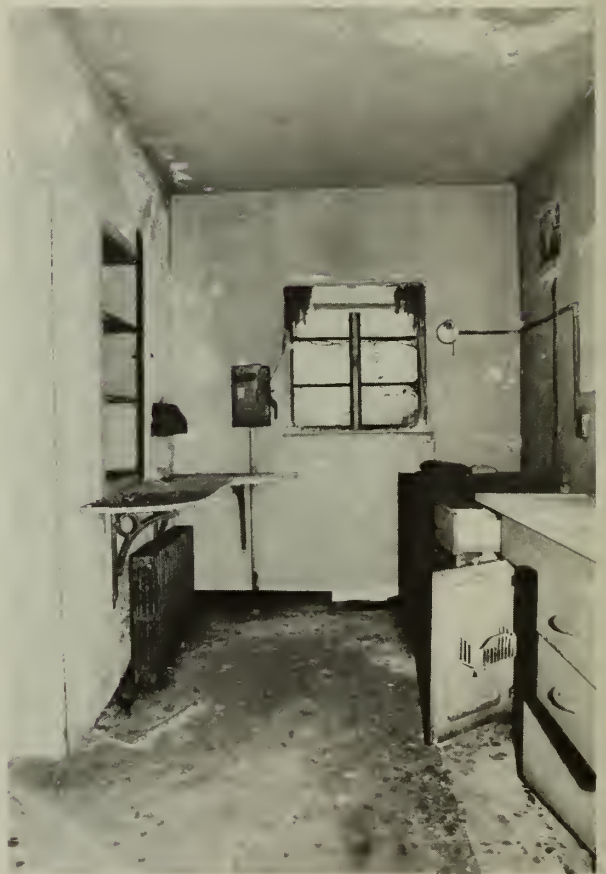
24. Room 105, view north.

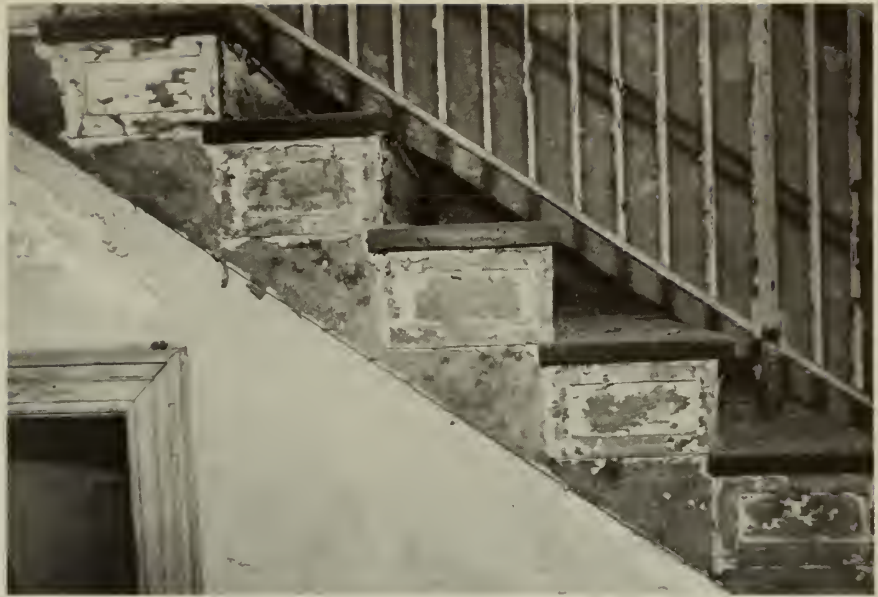
25. Stairs, paneled stringer.

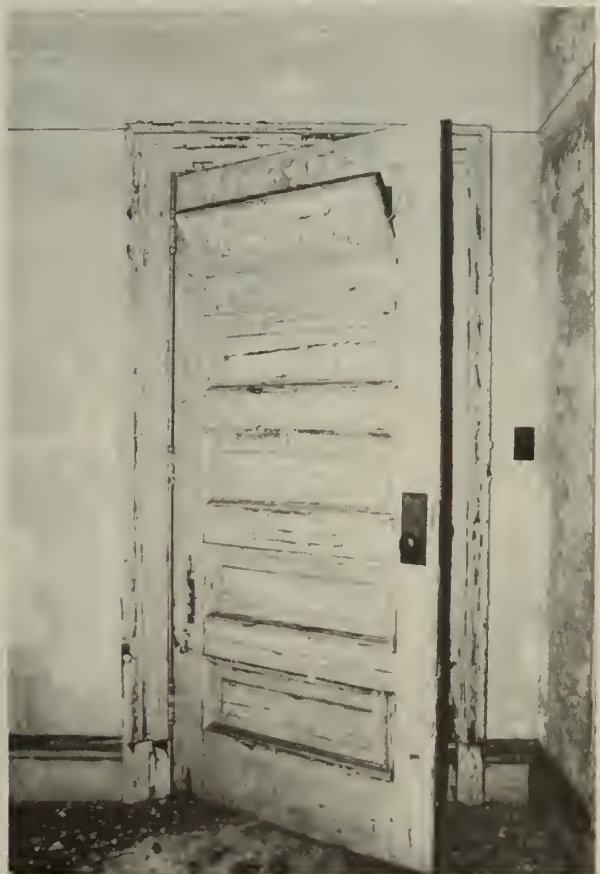
26. Door with hinged upper panel, room 205.

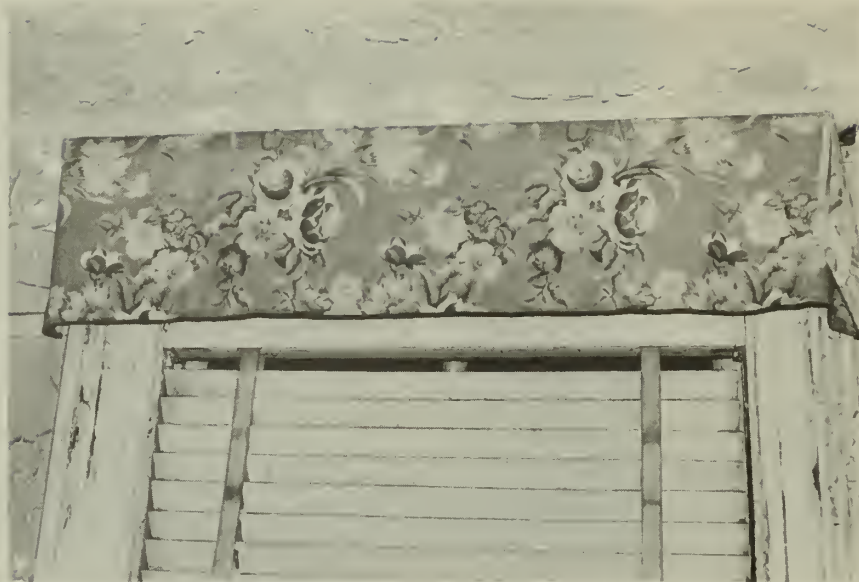
27. Valance, room 202.
